3.2.4 POLYFUSION WELDING: REPAIR OF A DAMAGED PIPE

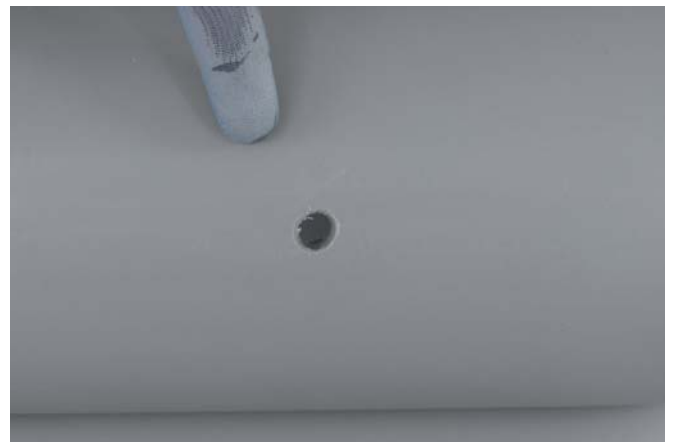
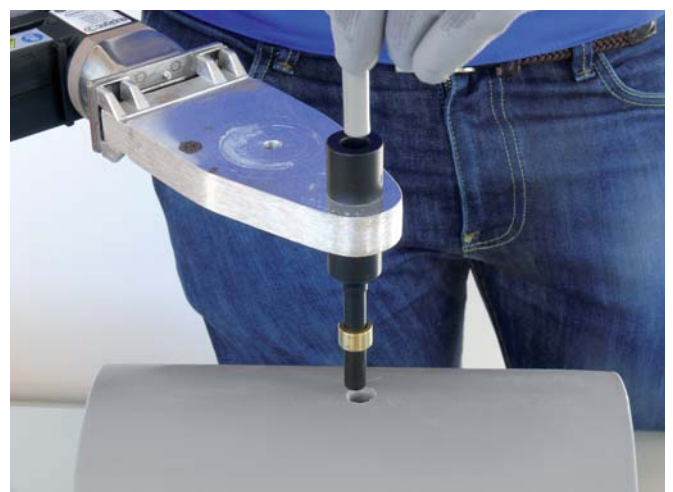
Enlarge the hole up to a diameter of 6 mm (approx. ¼") or 10 mm (approx. ⅜") with a suitable tip.

Make sure that the hole caused by the puncture has not damaged the other inner surface of the pipe or fitting.

Insert the male die pair into the pipe hole and the repair cap into the female die pair.

After the insertion, heat up for 5 seconds.

Once the heating time is over, insert the male cap inside the hole without rotating.

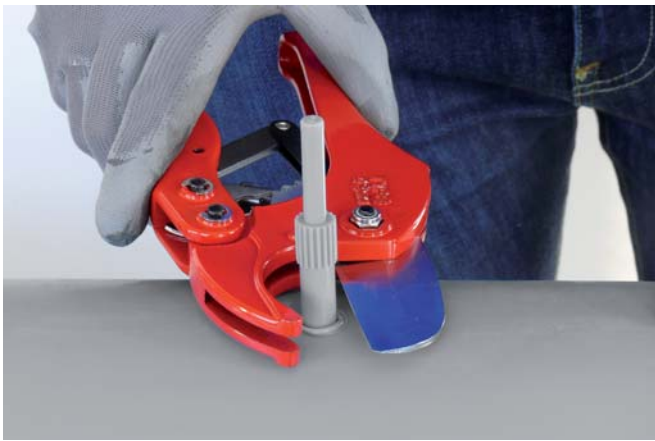
Wait for a cooling time of 1 minute and cut the cap.

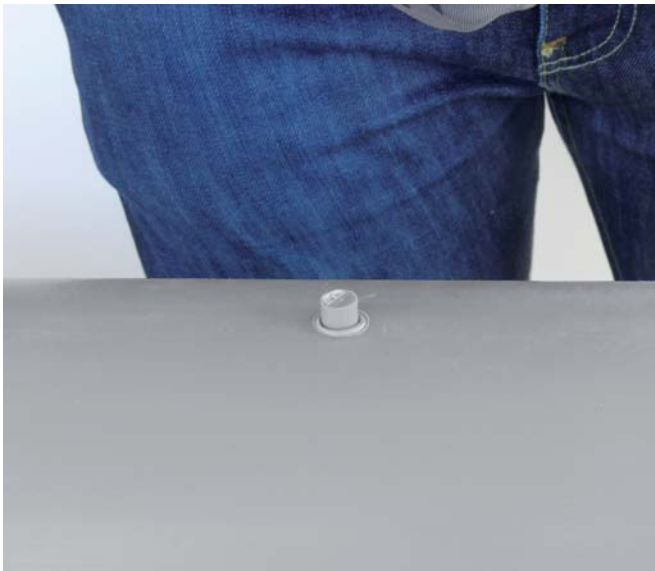
The picture shows how the pipe looks after the repair.
